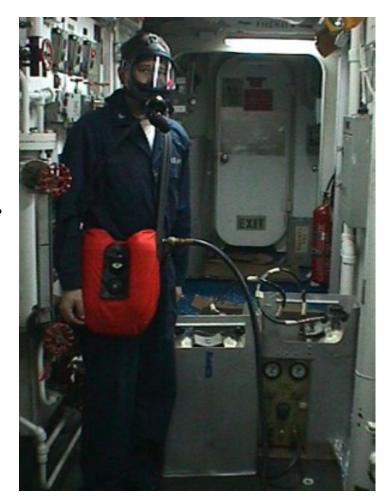
INSURV SAFETY CONCERNS SAR/SCBA for GFE

- > SAR/SCBA equipment is not being maintained IAW PMS.
- Bottles are not hydrostatic tested (every 3yrs).
- Gages are not tested/calibrated.
- Bottles are low in pressure.

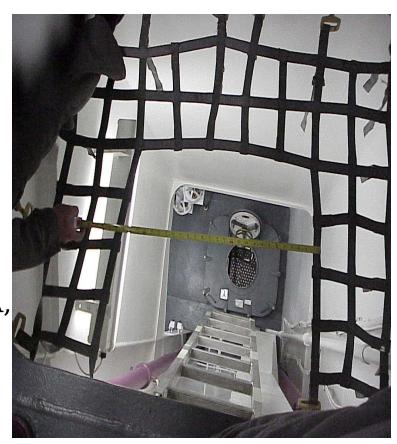
INSURV SAFETY CONCERNS ACCESS TRUNK SAFETY NETS

Incorrect installation/design of access trunk safety nets.

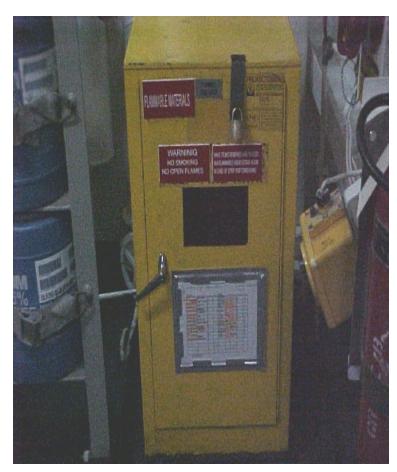
INSURV SAFETY CONCERNS IN-USE FLAMMABLE STORAGE

Not being maintained IAW the Q-36R Maintenance Requirement Card (MRC) 98 Y72L N from DCPO MIP 6641.

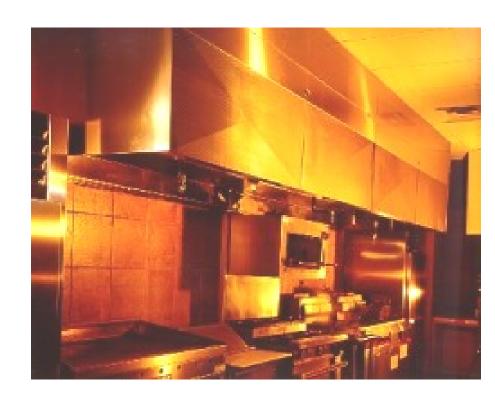
GAYLORD HOOD INTERCEPTOR SYSTEM

Shipboard hot water heaters are not supplying hood system with the required minimum temperature of 160F.

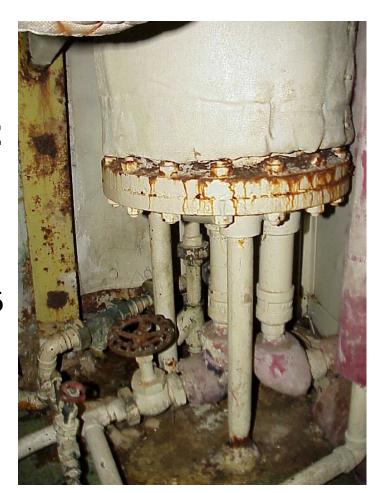
STEAM WATER HEATERS for WASHROOM

- MATERIAL CONDITION.
- OPERATING TEMPS LISTED IN PMS EXCEED THE SAFETY RANGE OF NSTM 533.
